**WASTE MANAGEMENT DIVISION
RCRA ENFORCEMENT SECTION
RCRA COMPLIANCE EVALUATION INSPECTION REPORT**

Purpose: RCRA Compliance Evaluation Inspection

Facility Location: Metco Metal Finishing, Inc.
3508 East Corona Ave.
Phoenix, AZ 85040-2842

Date of Investigation: March 20, 2001

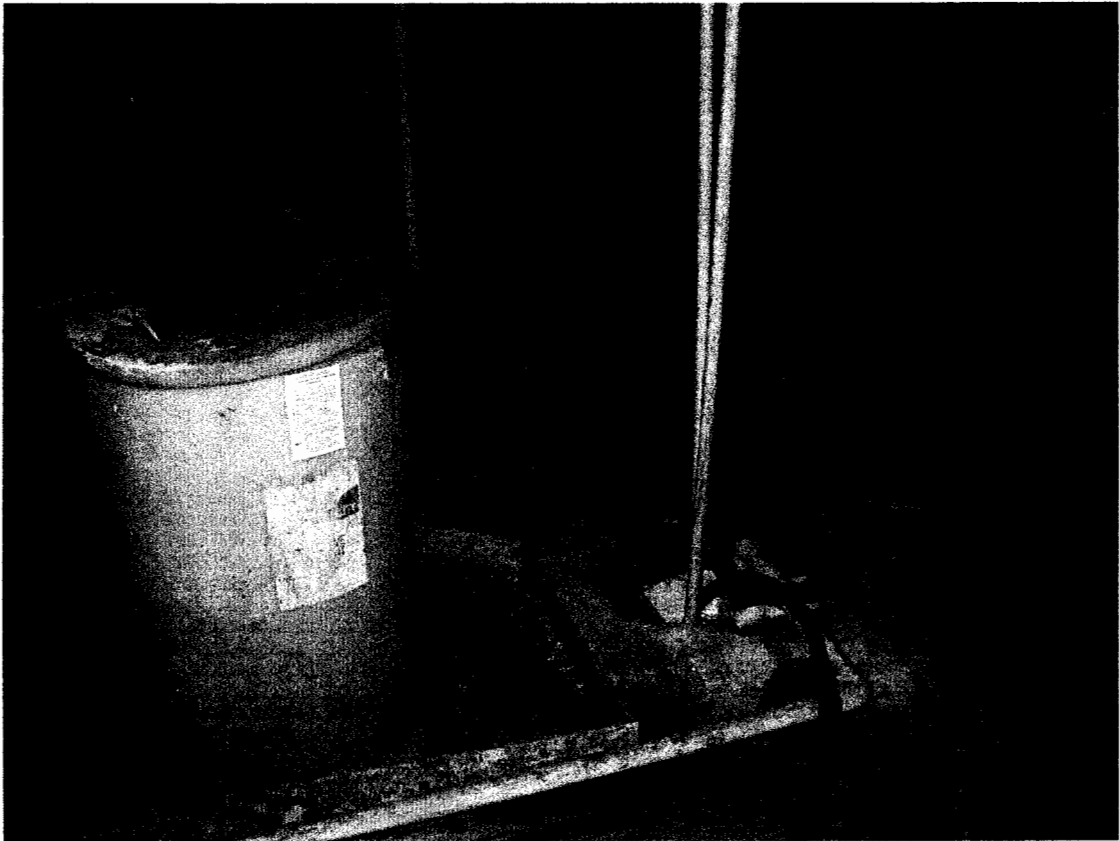
1. Wastewater Treatment System's discharge area

The inspectors walked through the interior of the plant, noting the wastewater discharge area (photo #1), the weir box, the plating lines (photo #2), and the wastewater treatment system. Each plating area had a separate dike for containment. No hazardous wastes were observed.

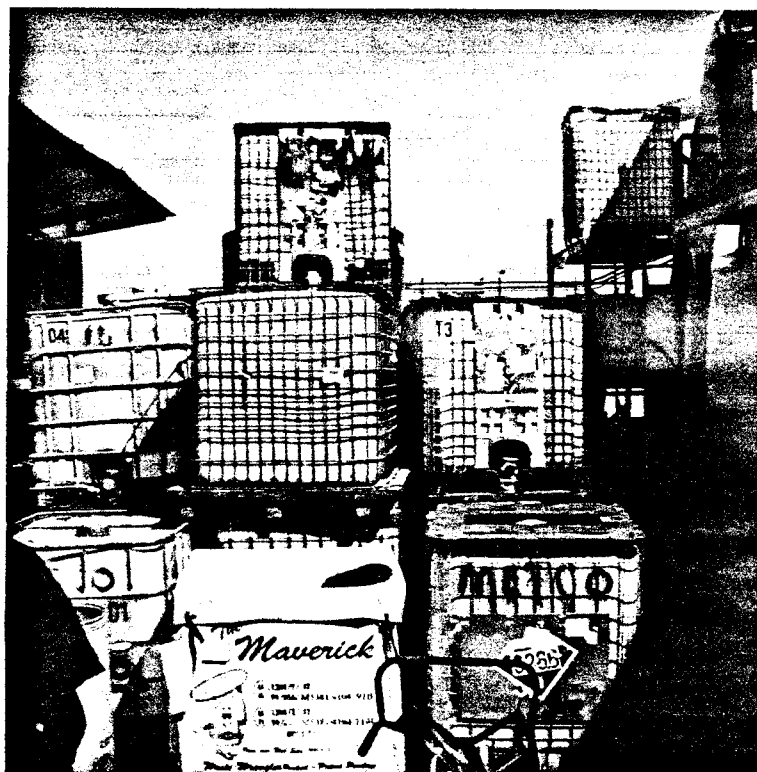
3. Totes in 90 Day Storage Area Djacent to Chemical Storage

Field Inspection Observations: The thirty 275-gallon totes in the 90 day storage area were not separated by adequate aisle space.

Action Taken by the Facility: In a letter dated April 5, 2001 (Attachment 6), Mr. Williams stated that a new waste treatment system is expected to reduce the use of totes and allow for adequate aisle space in the 90 day storage area.

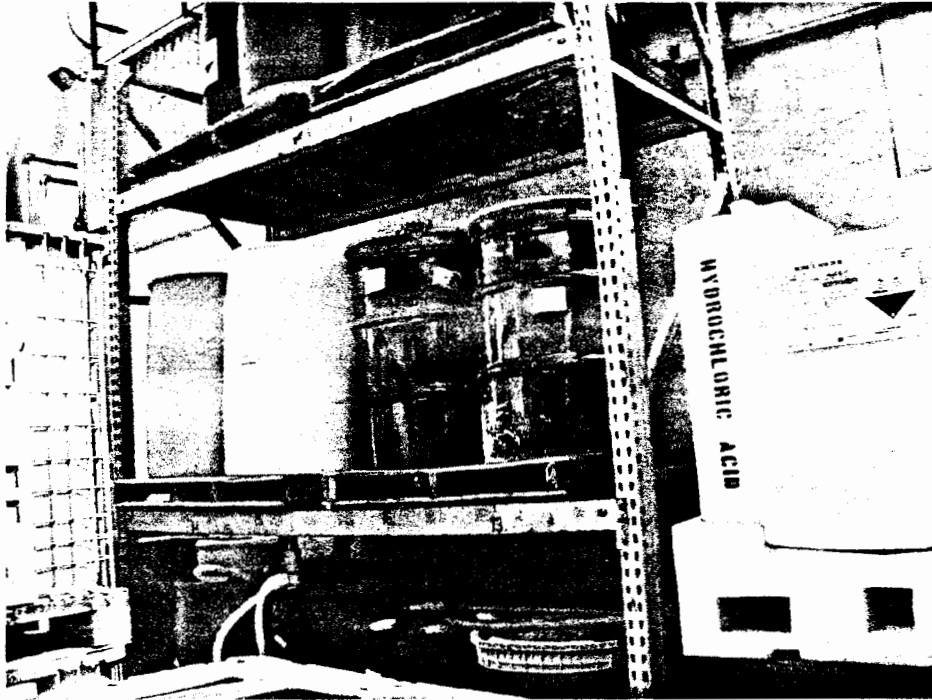
5. Satellite Accumulation Area in Chemical Storage Area
(Combination Waste and Product Storage)

Adjacent to the 90 day storage area were four 55-gallon drums containing paint waste, fluorescent bulbs, and caustic solution (Photo #5). The drums were properly labeled. No violations were noted.

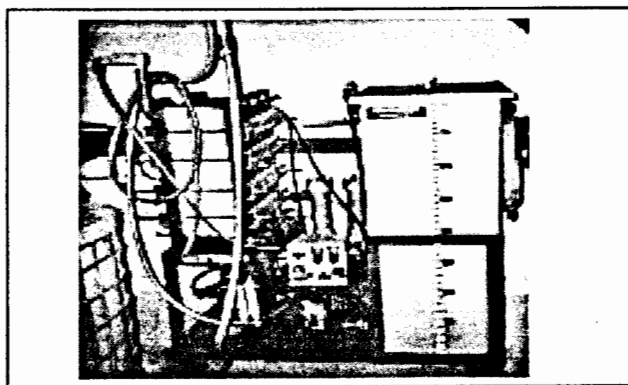
Figure 3. Full-scale electrodialysis unit at Metco
